TOYOTA LANDCRUISER 200 FITMENT MODIFICATION

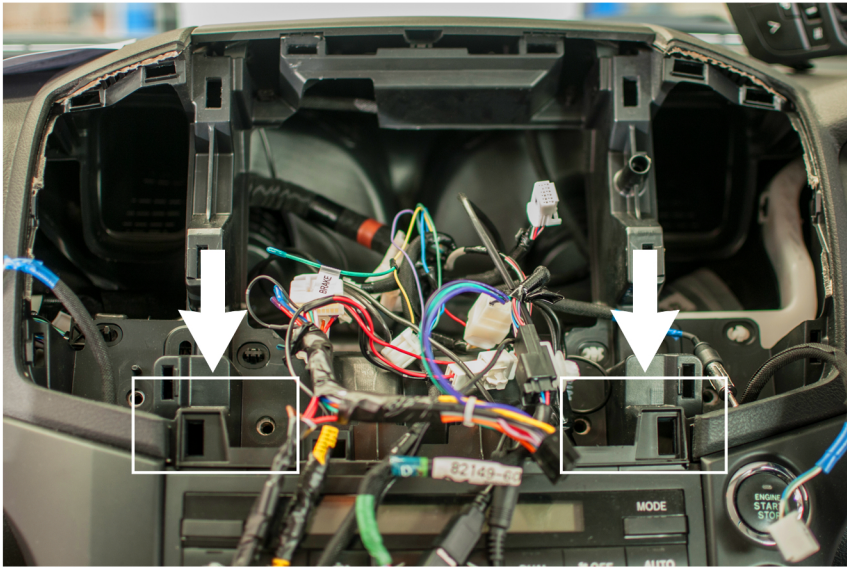
Some 200 series may have an extra piece of abs plastic on the facia mounts that needs to be removed for a flush fit.

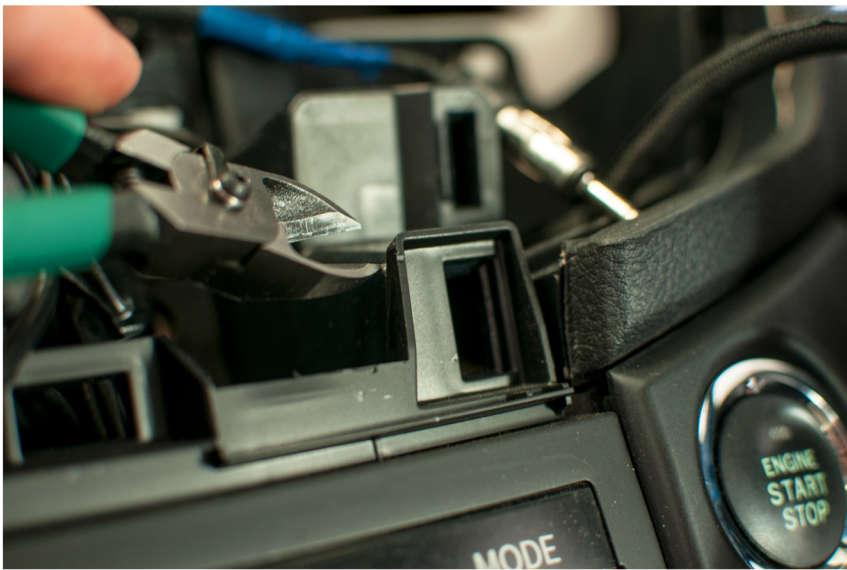
You can see in this image where the new facia makes contact with plastic. A small section must be trimmed away, from just below the mark, across to the outer edge.

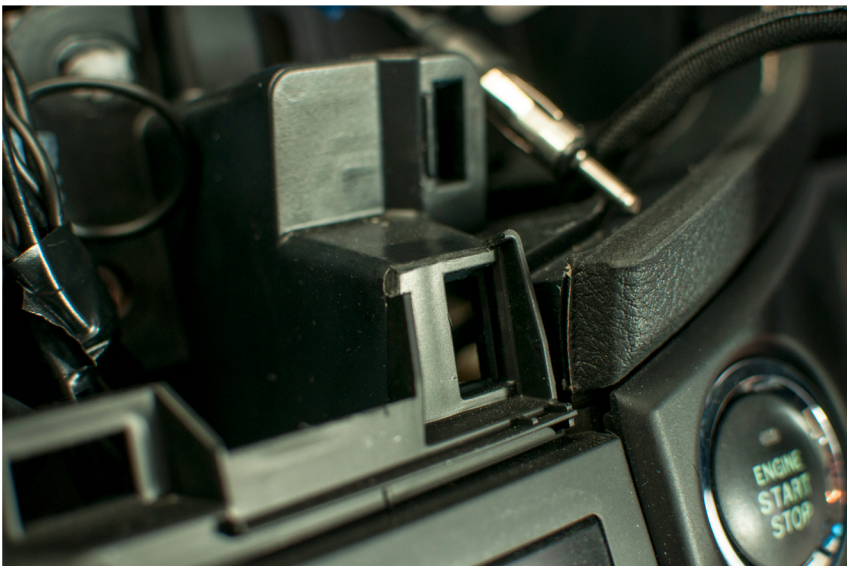
The final result should look like this. This needs to be done on both sides
